PROGRAM FOR ESTABLISHING LONG-TIME FLIGHT SERVICE PERFORMANCE
OF COMPOSITE MATERIALS IN THE
CENTER WING STRUCTURE OF C-130 AIRCRAFT

PHASE III - FABRICATION

September 1974

Prepared under Contract No. NAS 1-11100 by
LOCKHEED-GEORGIA COMPANY
Marietta, Georgia

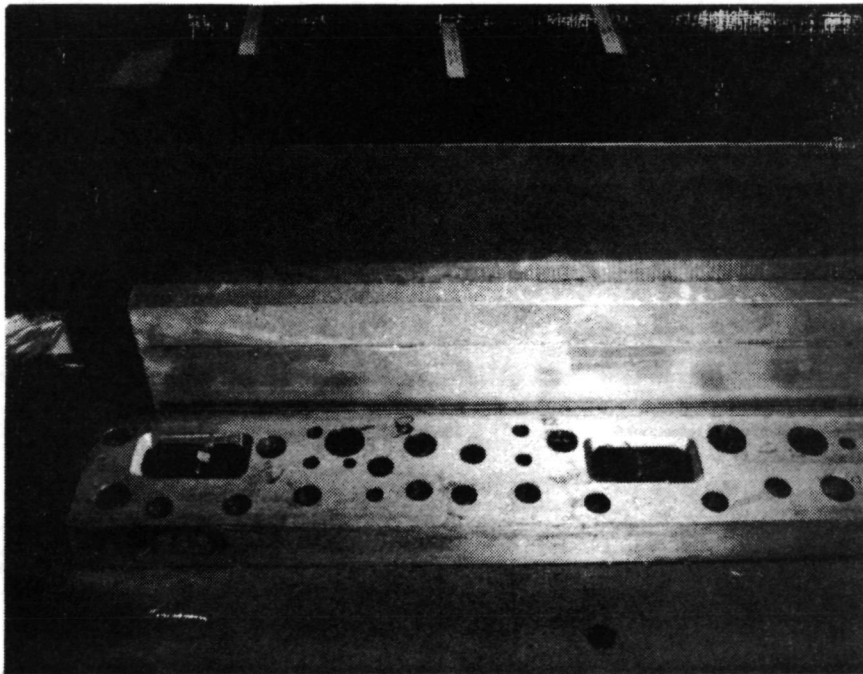
FIGURE 23.- STRENGTHENED END RESTRAINT OF COOL TOOL

Thermal expansion of the first full bonding load of five stringers caused the end restraint blocks on the cool tool to deflect, allowing the ends of the stringers to move upward and crippling the stringer ends. Some were usable because the crippled ends were in an excess area which was later machined away, but one or two had to be scrapped. In order to eliminate this deflection, several dowel pins and bolts were added to the restraint block and between the longitudinal beams and the top surface plate of the cool tool. No further problems with end block deflection occurred.

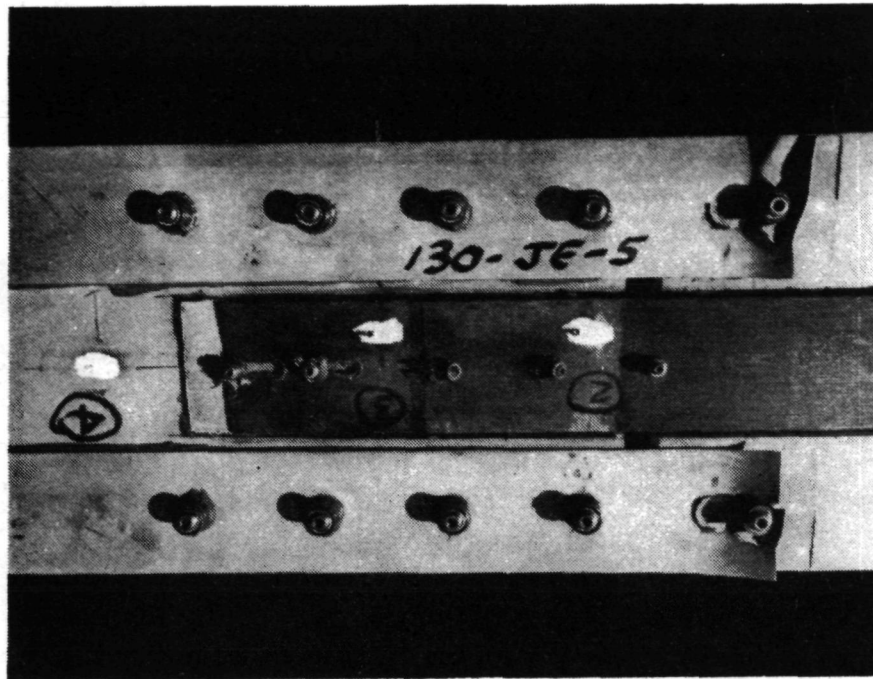
Test article laminates were bonded to metal plates with cool-tool techniques and prepared for testing by secondary bonding of doublers and loading tabs, and application of strain gages. The JE-5 test component represented the skin laminate run-out configuration for stringer #18 on the lower surface at W.S. 200-220. This component was successfully tested to a tension load which exceeded airplane ultimate load requirements by approximately 30%. Failure occurred by net section fracture of the aluminum skin panel.

FIGURE 65. - 130-JE-5 FAILURE, LAMINATE SIDE

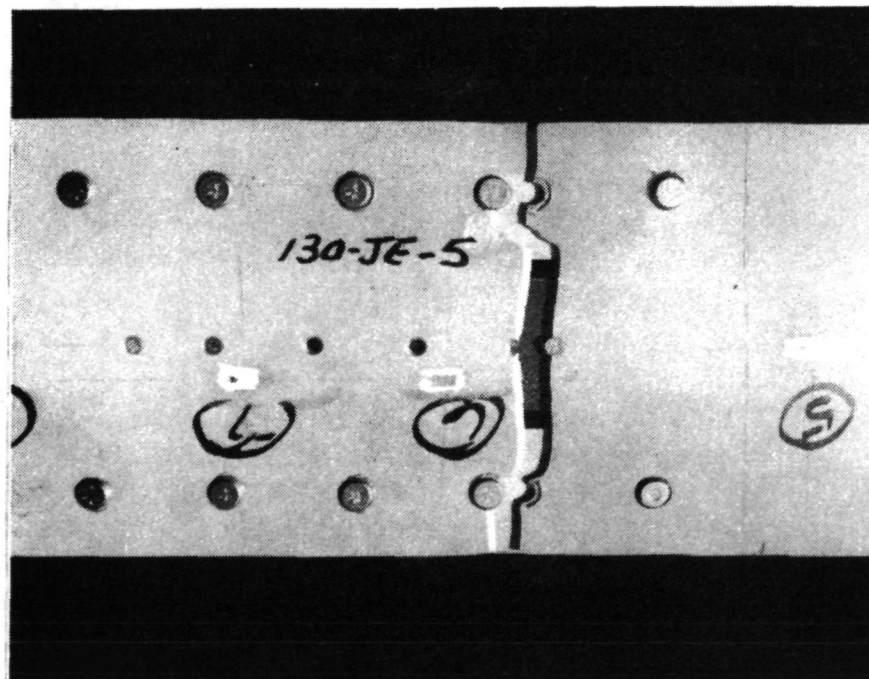
FIGURE 66. - 130-JE-5 FAILURE, SKIN SIDE

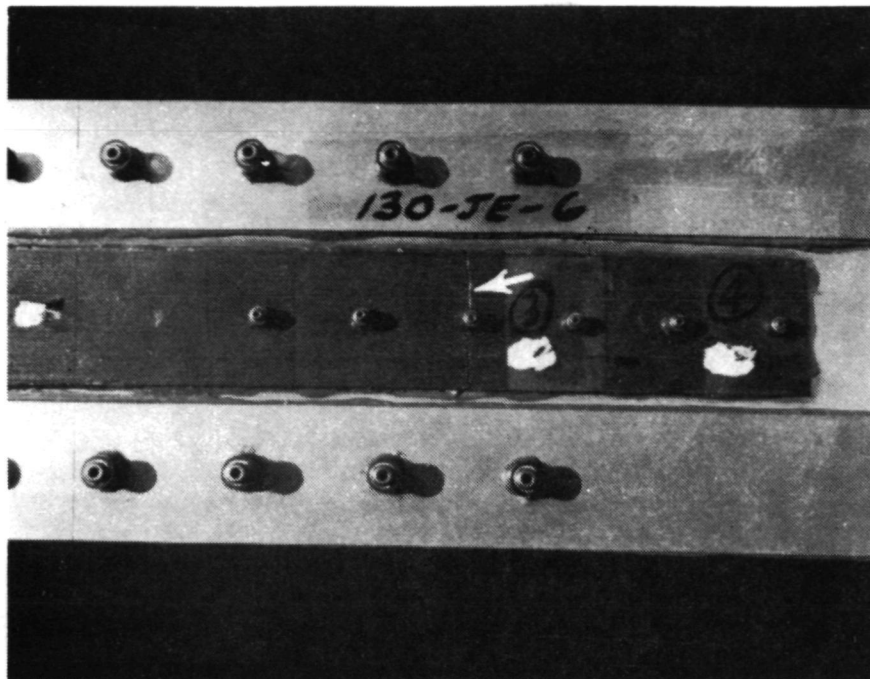
The JE-6 test component illustrated in Figures 59 and 60 simulated the skin laminate run-out configuration for stringer #18 on the lower surface at the W.S. 140 cut-out. This component was successfully tested to a tension load which exceeded airplane ultimate load requirements by approximately 42%. Failure occurred by net section fracture of the boron-epoxy laminate at a fourth fastener location near the laminate end. Strain data showed (Figure 61) that measured strains in the proximity of the failure were equal to, or exceeded, the boron-epoxy design ultimate tensile strength of 1.24 GN/m^2 (180 KSI).

FIGURE 67. - 130-JE-6 FAILURE IN LAMINATE

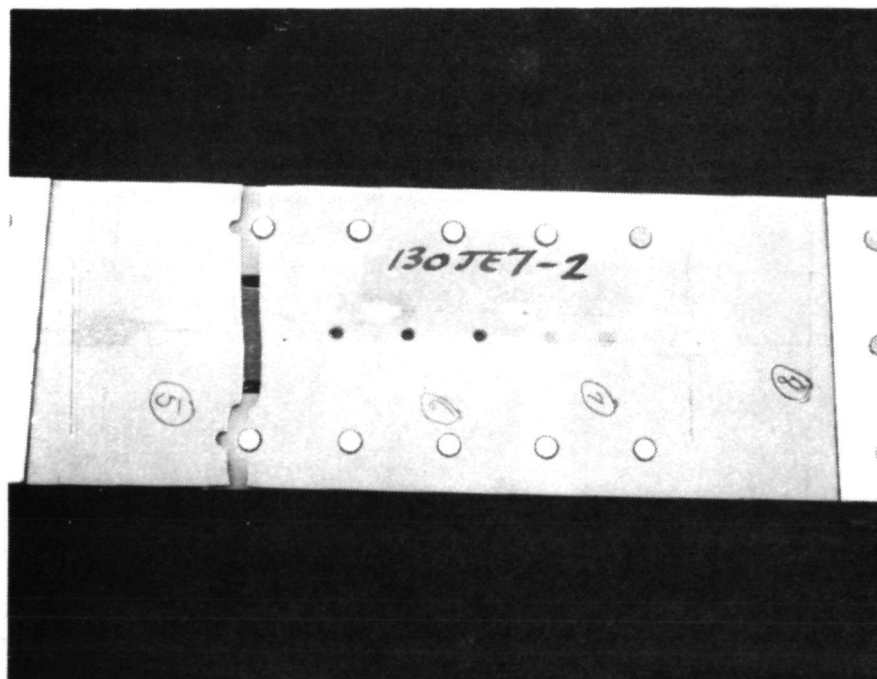
The JE-7 specimens were identical in configuration to JE-5 but used a laminate from a different autoclave run. Test results and failure modes were almost identical to those obtained from the JE-5 specimen. Table VIII summarizes the test results.

FIGURE 68. - SKIN SIDE OF FAILED 130-JE-7-2 SPECIMEN

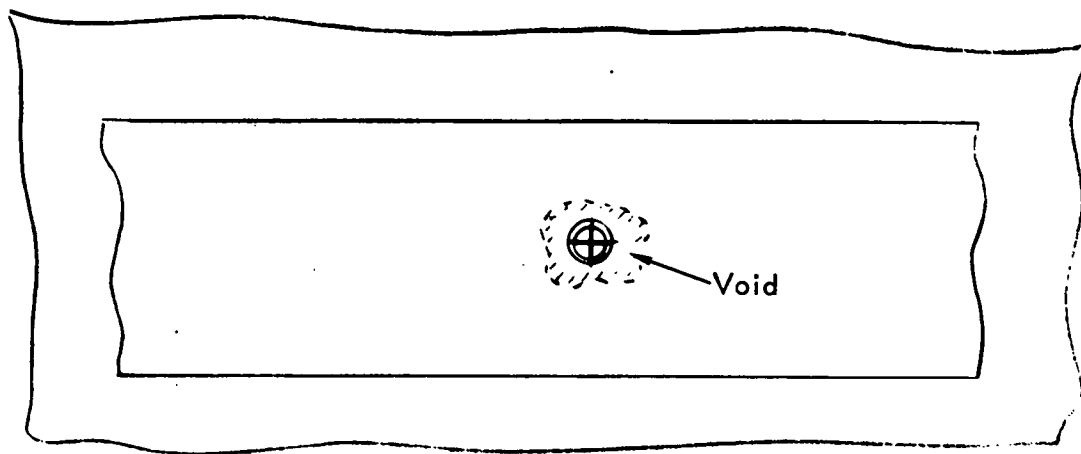
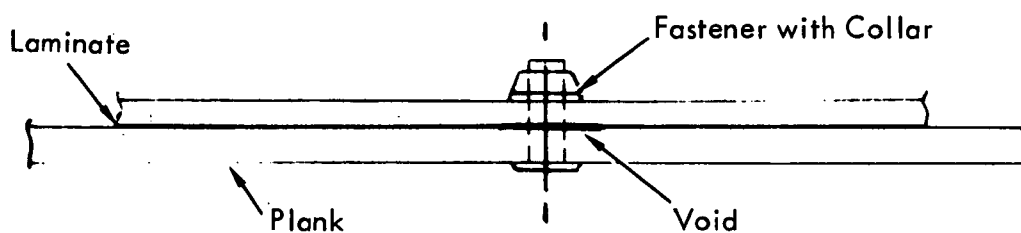
FIGURE 69. - REPAIR OF SMALL VOIDS

The under-laminate voids were of two general types: small, enclosed areas, and larger areas where the unbond extends completely underneath the skin laminate. The small, enclosed voids were repaired by drilling and injecting with EA 9309.1. A single fastener was then installed through the repair to prevent void propagation. This repair is illustrated in Figure 69.

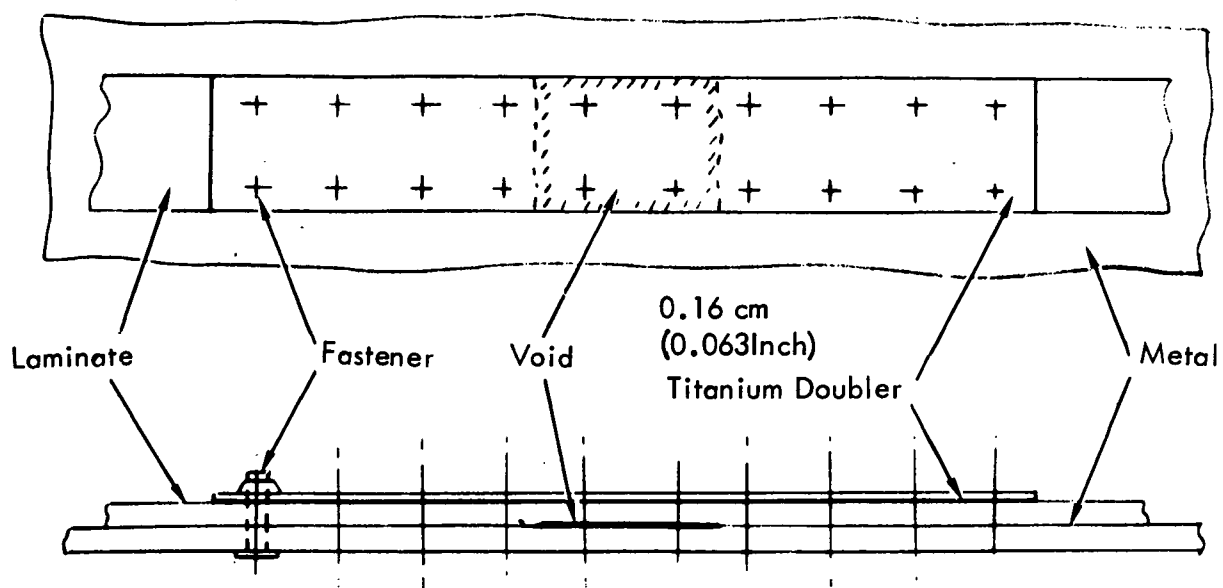
FIGURE 70. - REPAIR OF LARGER VOIDS

The more extensive voids were repaired as illustrated in Figure 70. Any old adhesive in the void areas was removed and replaced with EA 9309.1 room temperature curing epoxy adhesive. A 0.16 cm (0.063 in.) thick titanium doubler was bonded to the laminate over the void area, extending several inches beyond the void on either end. The entire repaired area was then fastened together with a double row of Hilok's spaced on about 3.2 cm (1.25 in.) centers.
